**PRESENTED AT AMERICAN ASSOCIATION OF DAM SAFETY
OFFICIALS - ANNUAL DAM SAFETY CONFERENCE, SEPTEMBER 2004**

**POTENTIAL FAILURE OF WEST GRAND LAKE DAM
DIAGNOSING AND AVERTING AN
IMMINENT FAILURE**

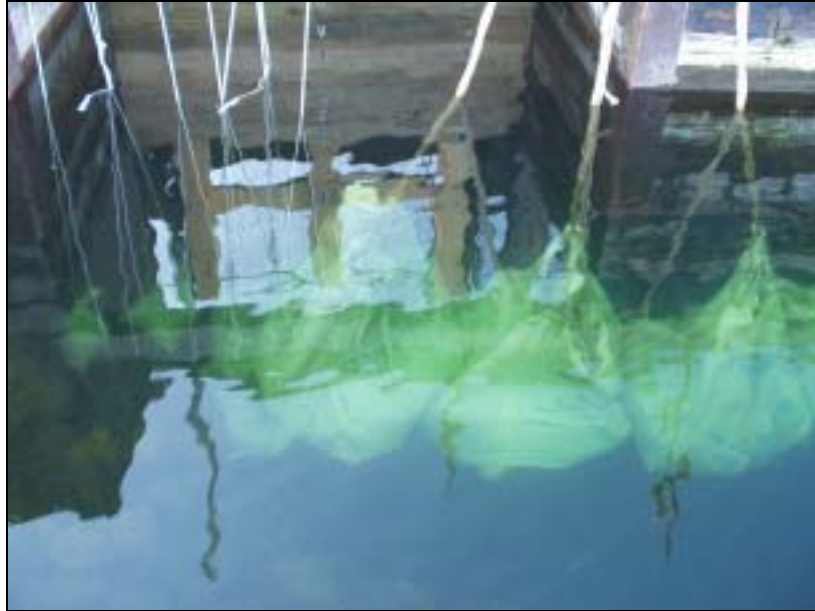
During the course of this inspection, several "hot spots" were detected along the cut-off location as well as along an existing concrete training wall between the gate structure and fishway. Sheet plastic was submerged with small sand bags over the suspect areas. Additionally, the contractor placed one cubic yard sized bulk grain bags on the areas of most concern.

Sandbags Filling Voids Upstream of Gate Apron

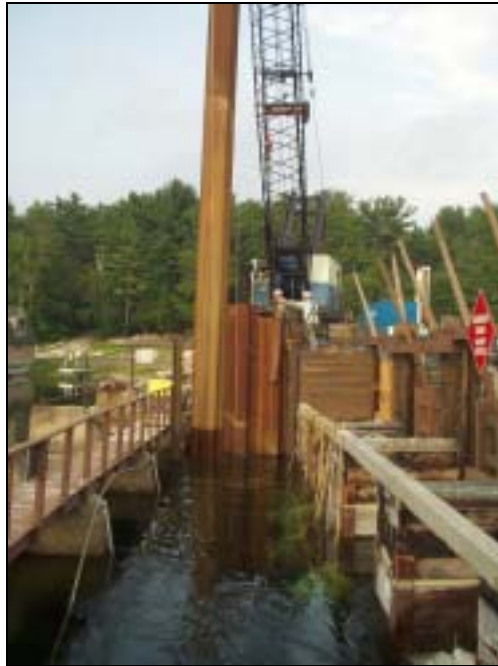
Installation of Phase I Cofferdam against Eastern Abutment

The design concept was to drive a steel sheetpile cofferdam in two phases creating a dry work space to conduct demolition and replacement activities. The plan called for extending the sheetpile cofferdam into the embankment to create a seepage path long enough to prevent future piping. Both phases included closure seals at each end. Additionally, all work was to be

performed behind the cofferdam, allowing the placement of concrete in the dry. Phase I enclosed gate bays 3, 4, and 5. Phase II enclosed gate bays 1 and 2.

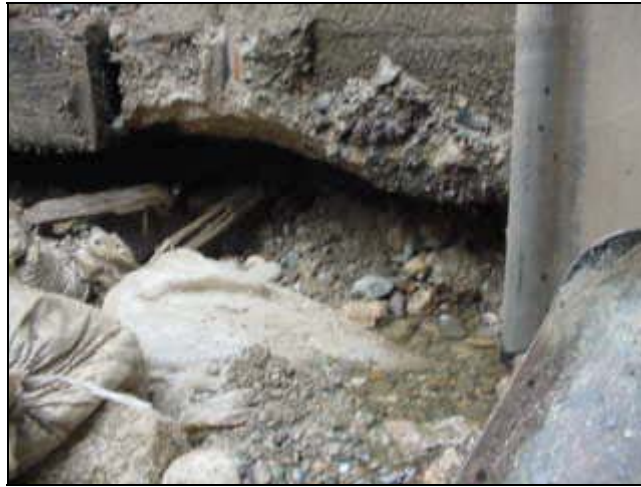
Void under existing concrete training wall discovered during dewatering.
Note embedded sand bags.

It was determined that water entering beneath the concrete wall was the major contributor to the leakage at gate bay five. Water apparently had entered from one side of the gate structure and exited the opposite. The flow was passing under the apron by way of the open cribwork totally masking the source of the problem area.

The wall was completely removed and the concrete apron was placed up against the sheetpile cutoff wall. A new concrete training wall was poured on top of the apron, re-establishing the separation between the fishway and the gate structure.

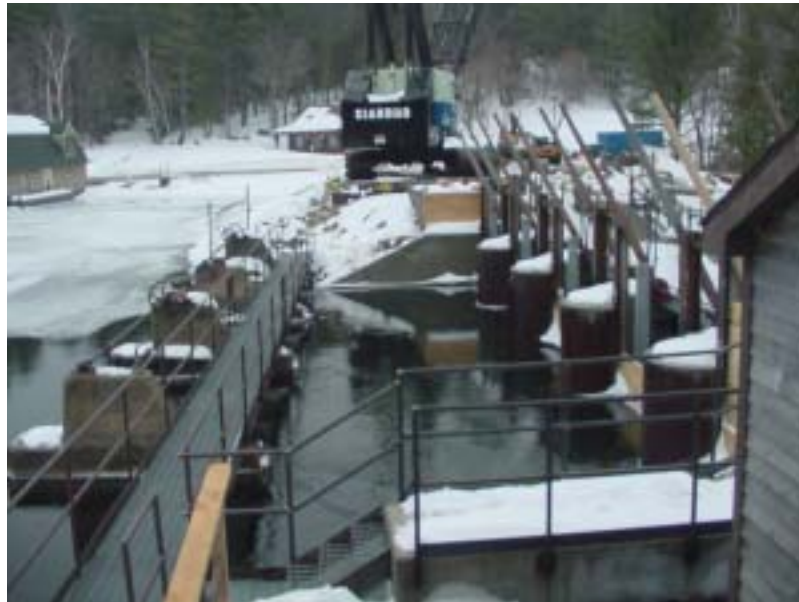
Completed Project

The installation of a steel sheet cutoff across the entire gate and fishway structure essentially eliminated the future concern for piping beneath the gate structure. To aid in future observations and maintenance of the structure, two stand pipes were installed and an under drain discharge pipe. The standpipes will be used to monitor any uplift beneath the concrete gate apron that would indicate excessive underflow building uplift. The under drain discharge pipe exits on the downstream side of the gate structure and provides a visual observation of the leakage. The discharge pipe is a four inch PVC pipe that is only flowing partially full. Remember the underflow/leakage that we started with was eighteen inches deep over a width of nine feet, not to mention other bay leakage and pier leakage. As can be seen from the reduction in leakage down to a small weeper pipe, the success of this project speaks for itself.
