26th USSD Annual Meeting

Gates and Gate Failures

Thomas L. Kahl, P.E.
(Presenter)

Kleinschmidt
Energy & Water Resource Consultants

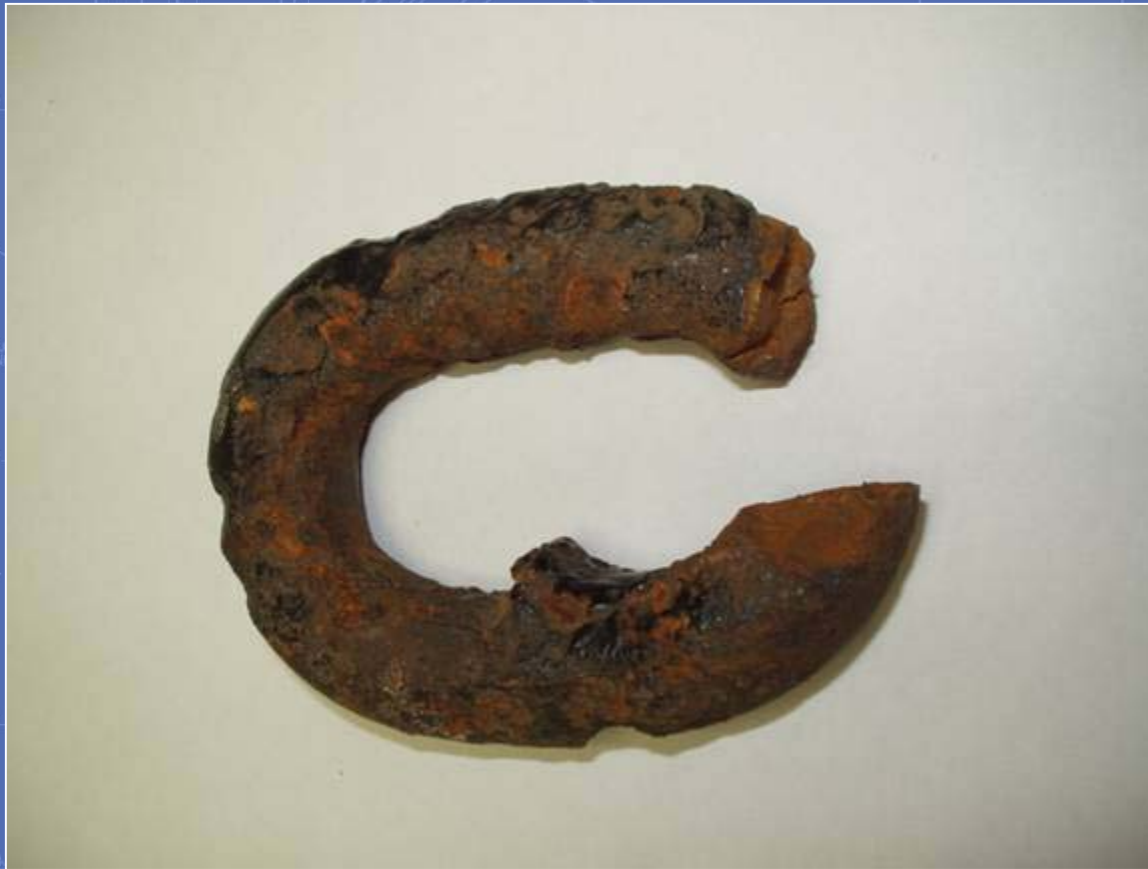
Broken Tainter Gate Chain Link

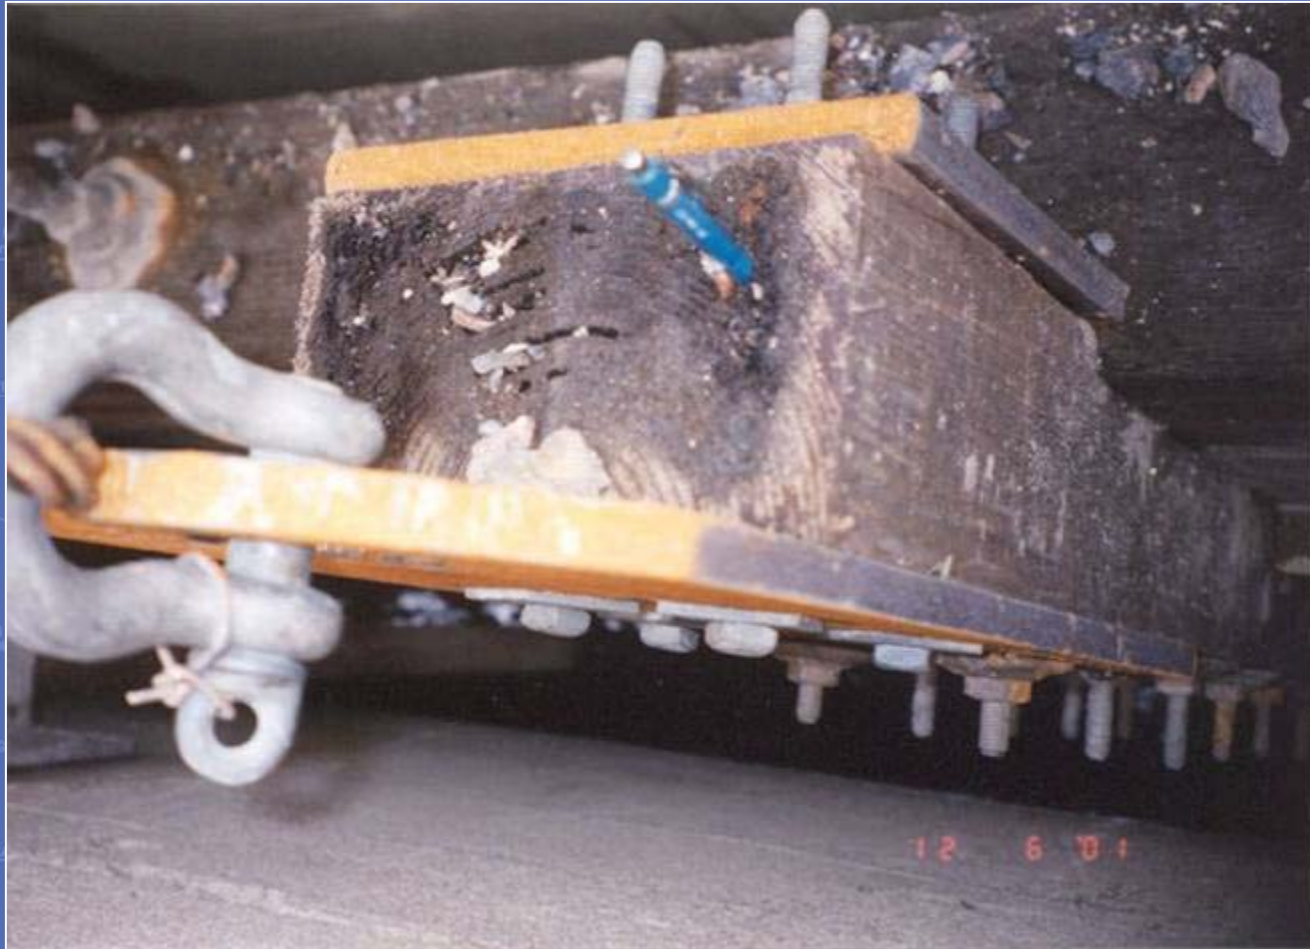
**Detail Of Ruptured Wooden Stem
Note Interior Decay**

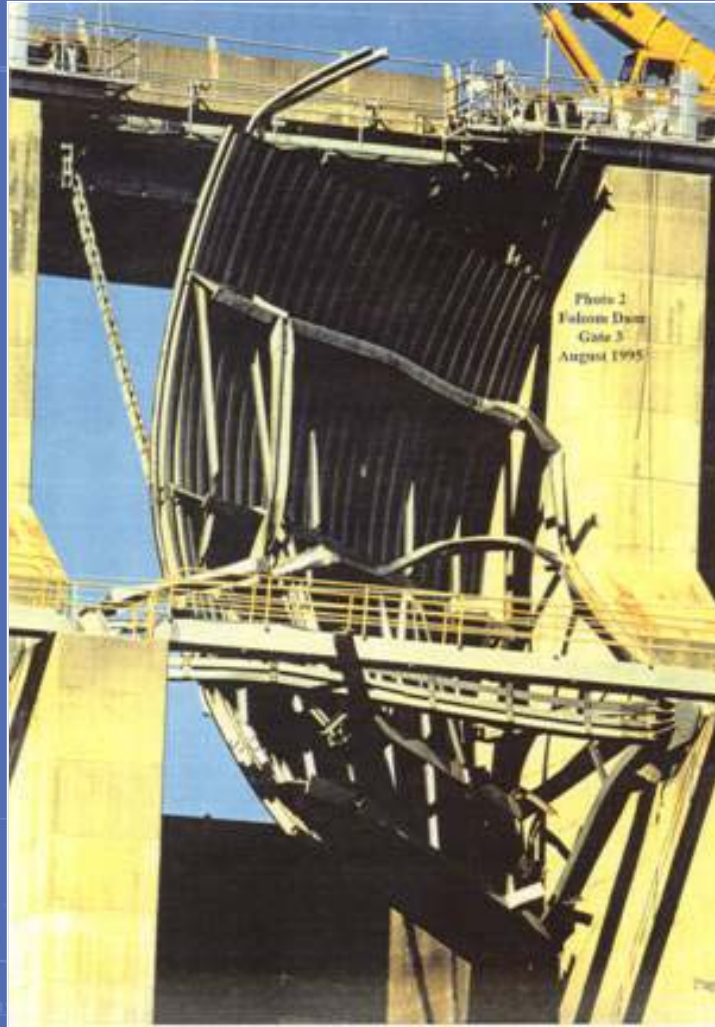
Failed Folsom Tainter Gate

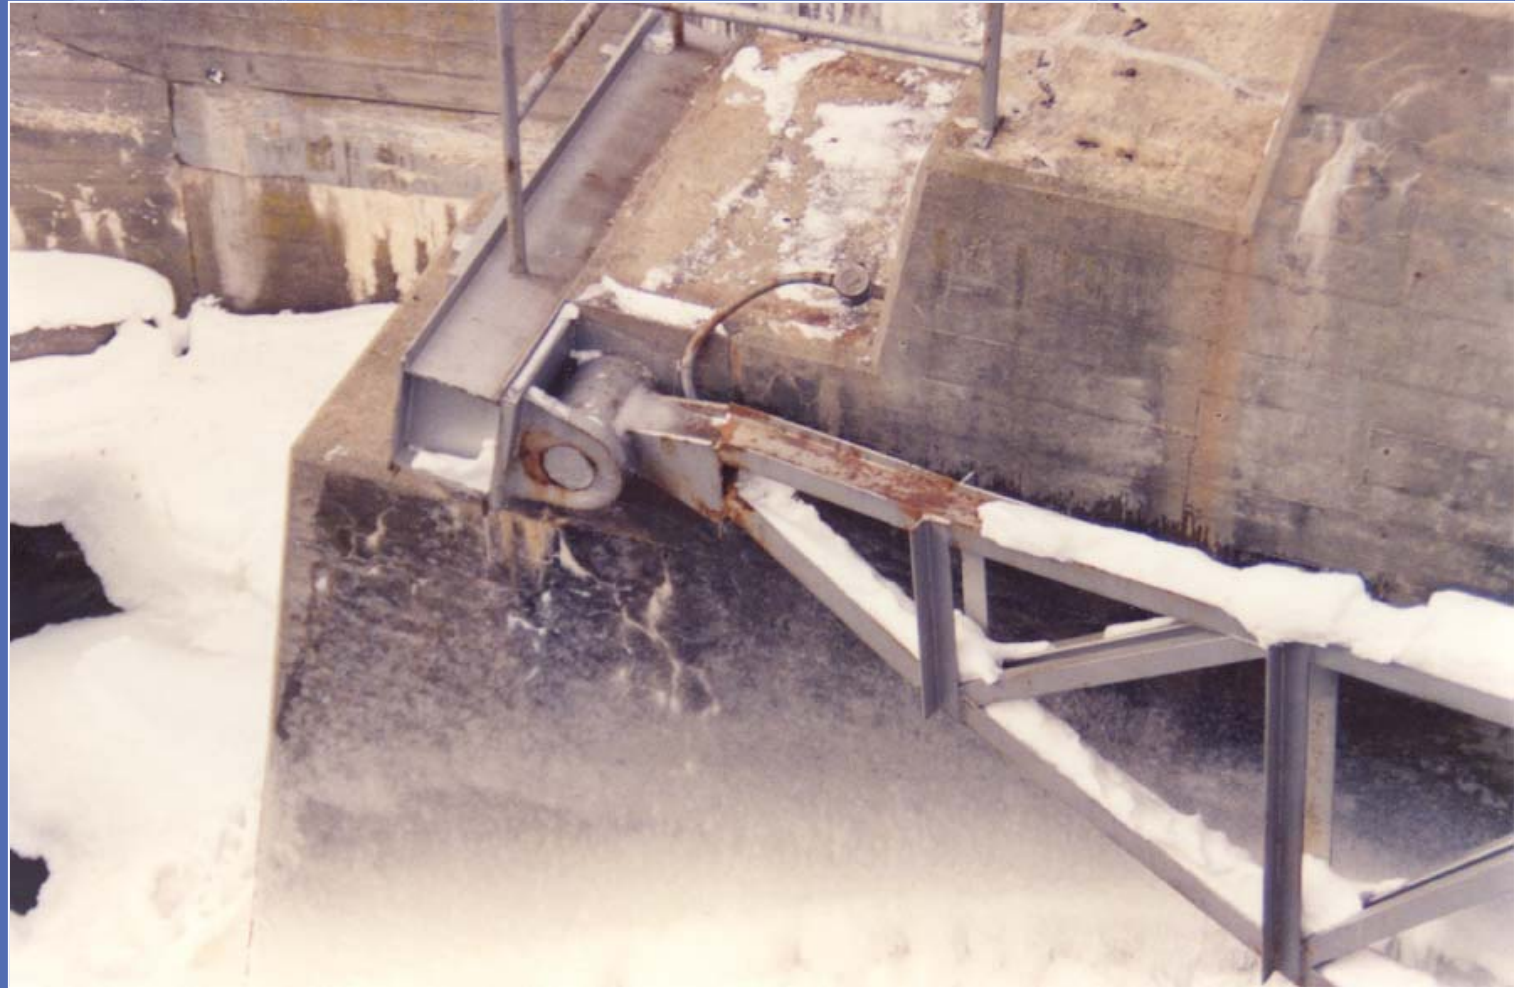
Failed Tainter Gate Arm

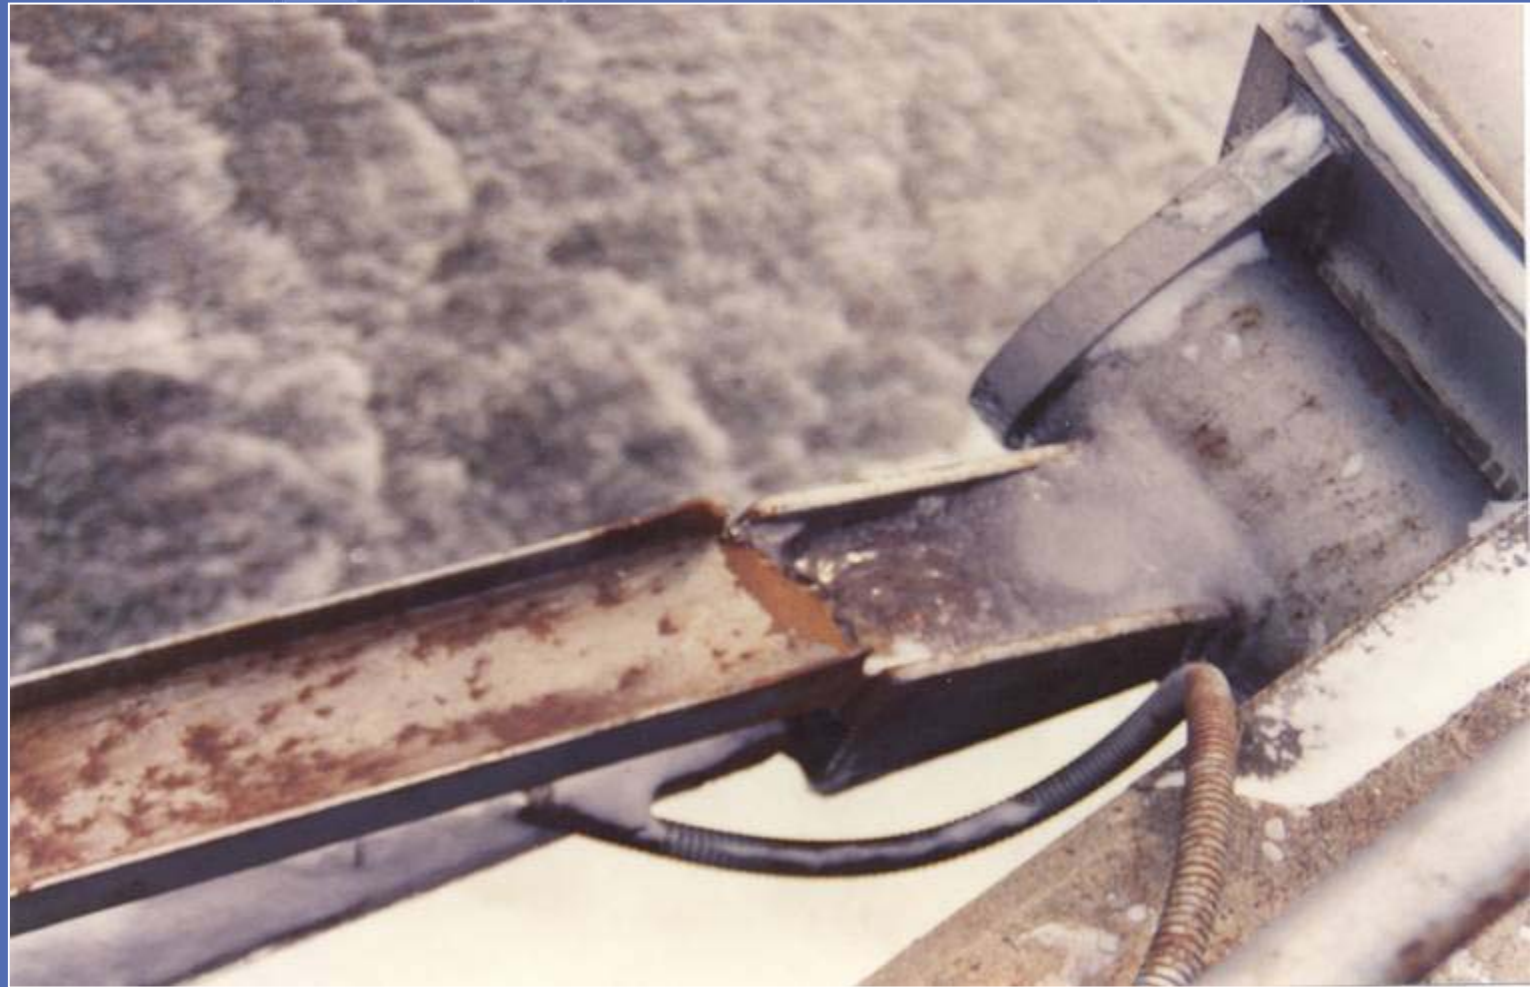
Detail of Failure

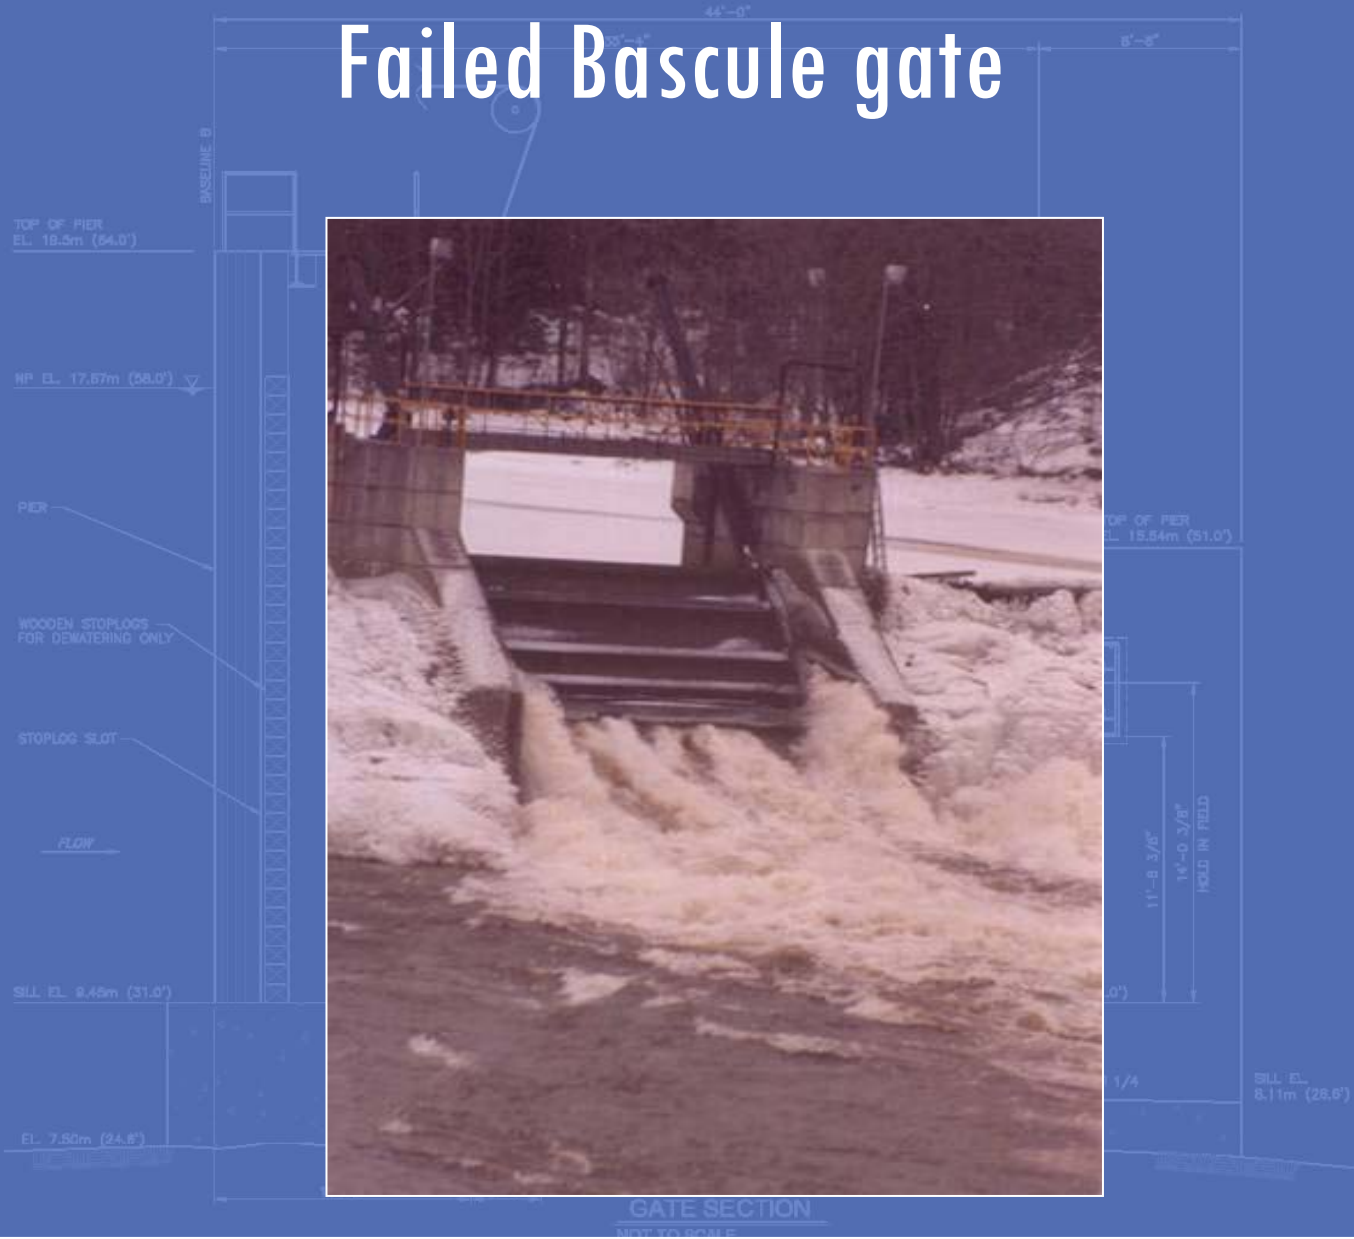
Failed Bascule gate

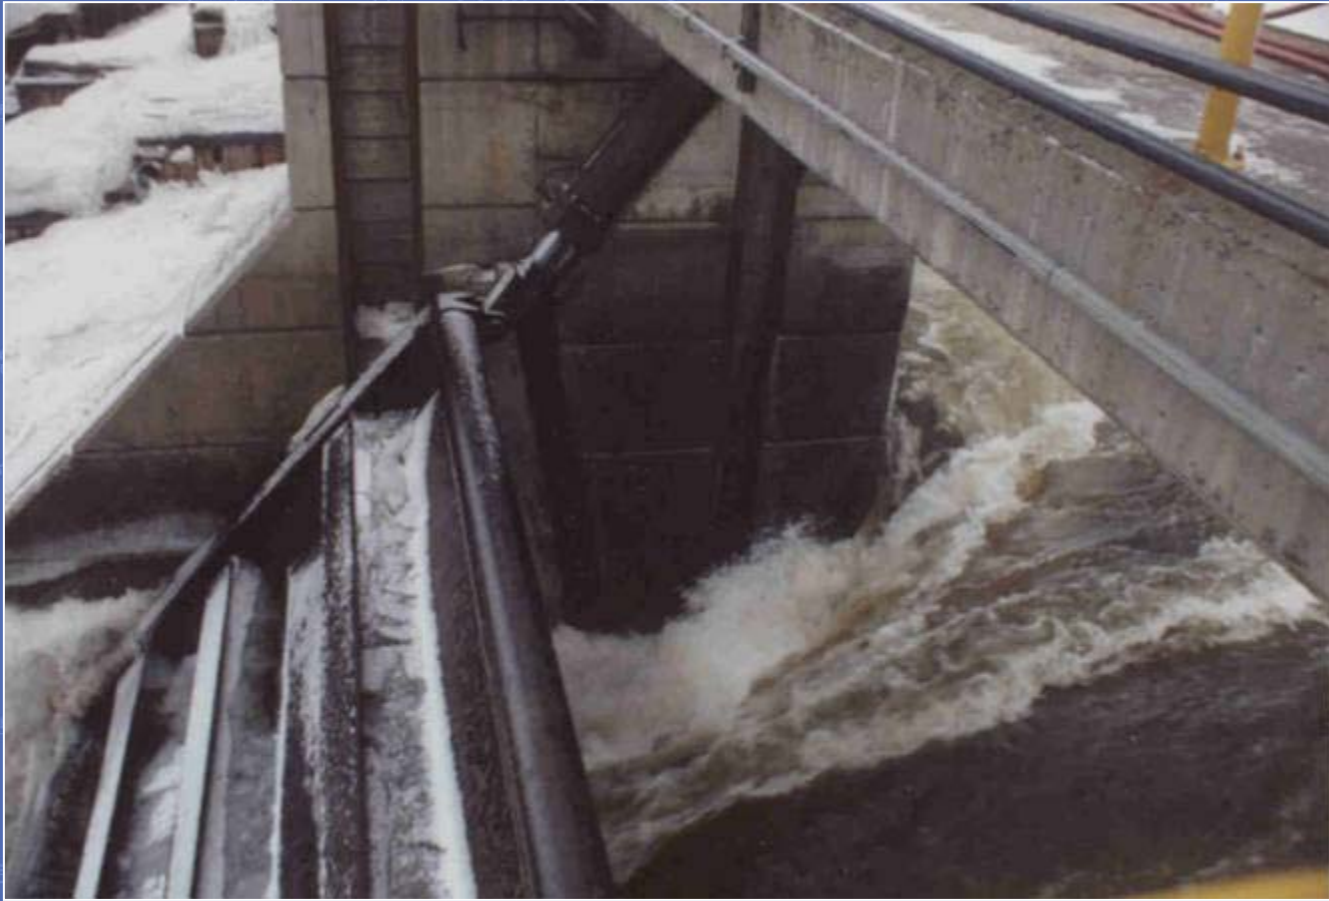
Gate Failed at Bottom of Side Beams

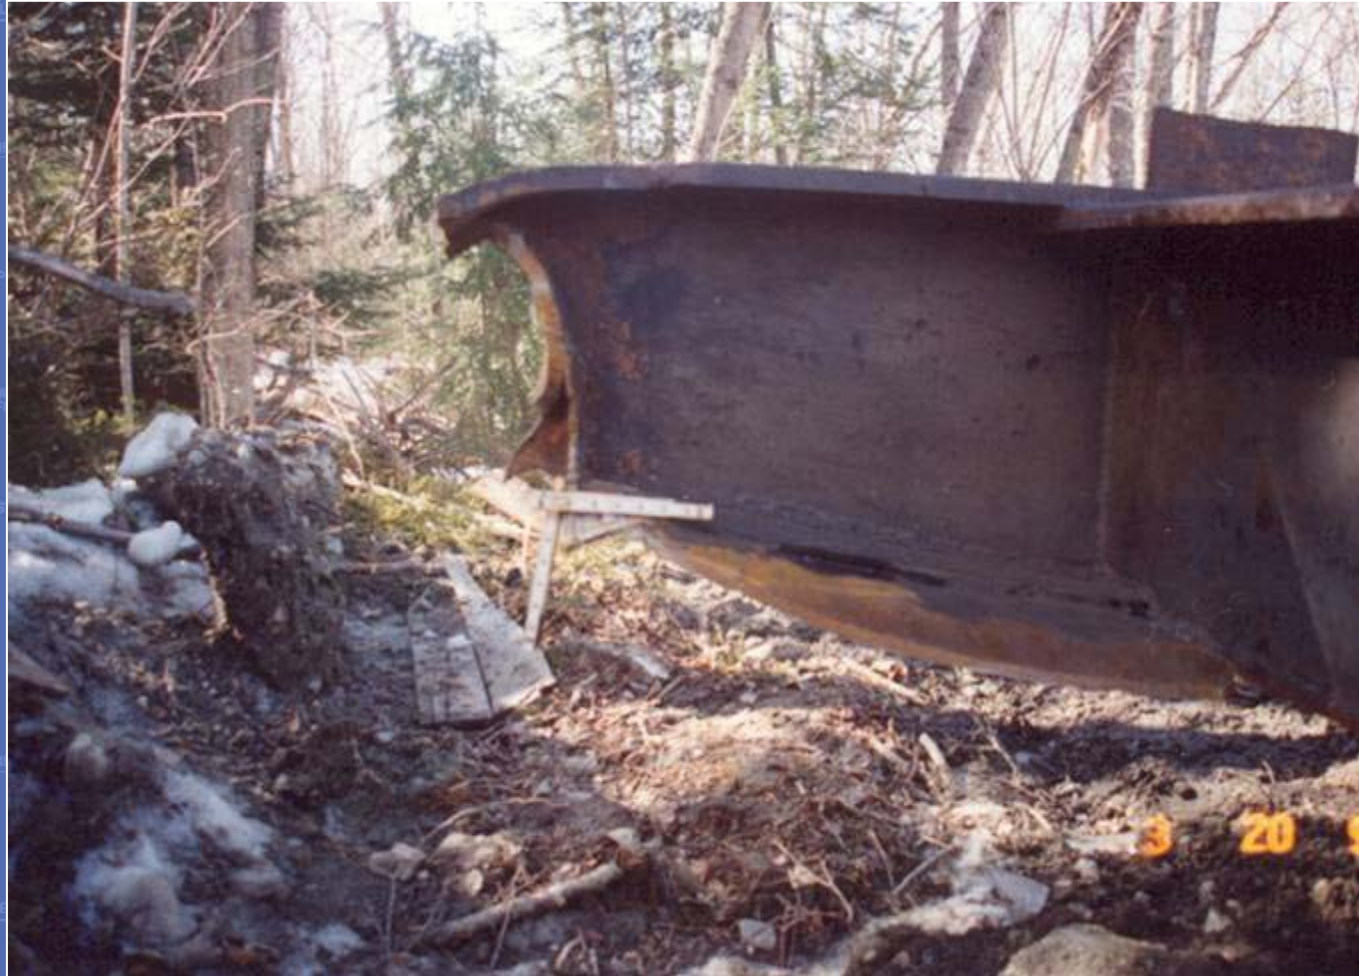
Detail Of Gate Arm Failure

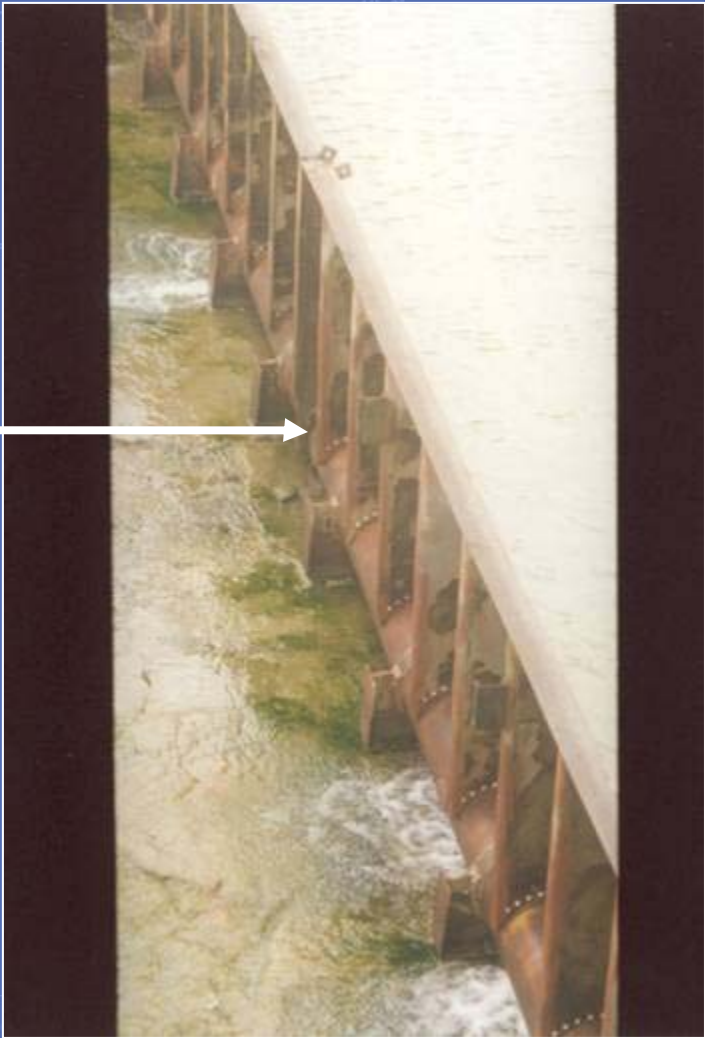
Bolted connection at gate's field splice

Missing And Deteriorated Bolts In Gate Splice

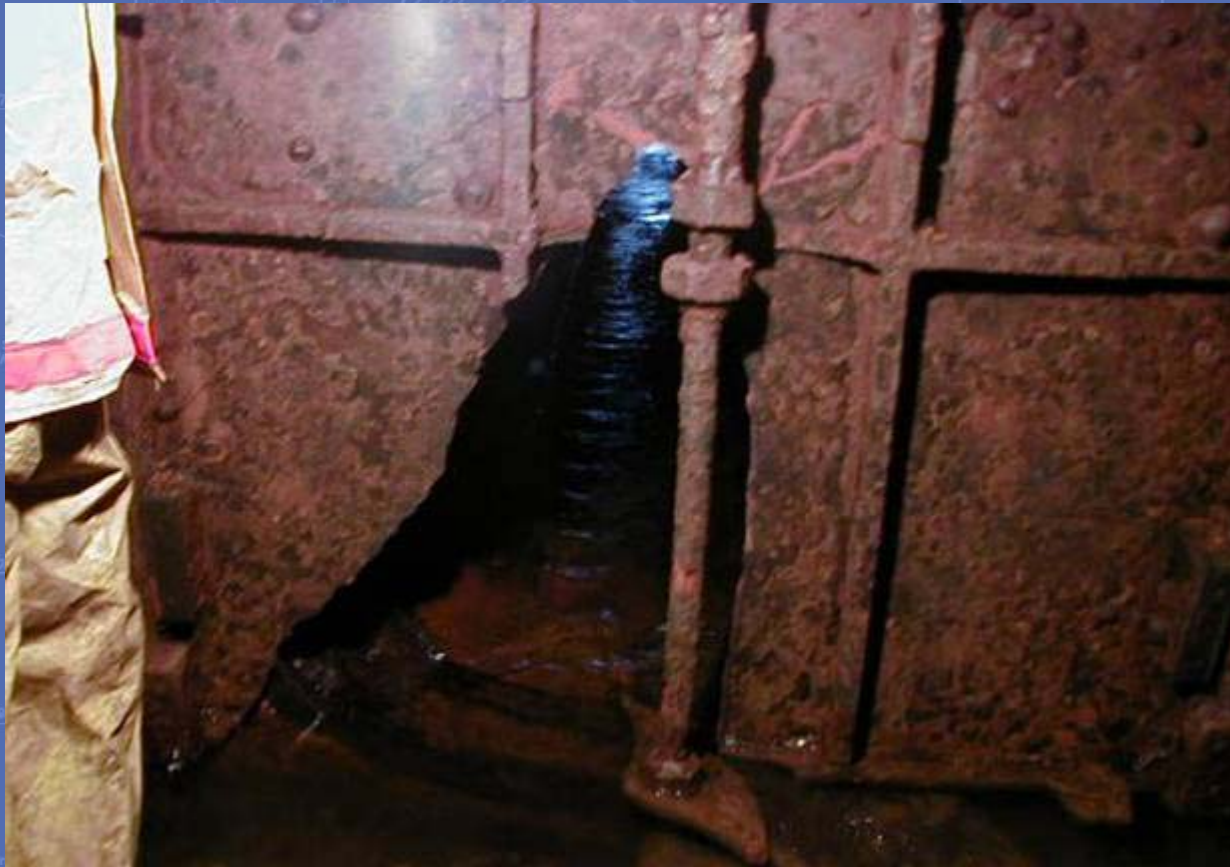
25" x 29" broken piece from 48" cast iron sluice gate

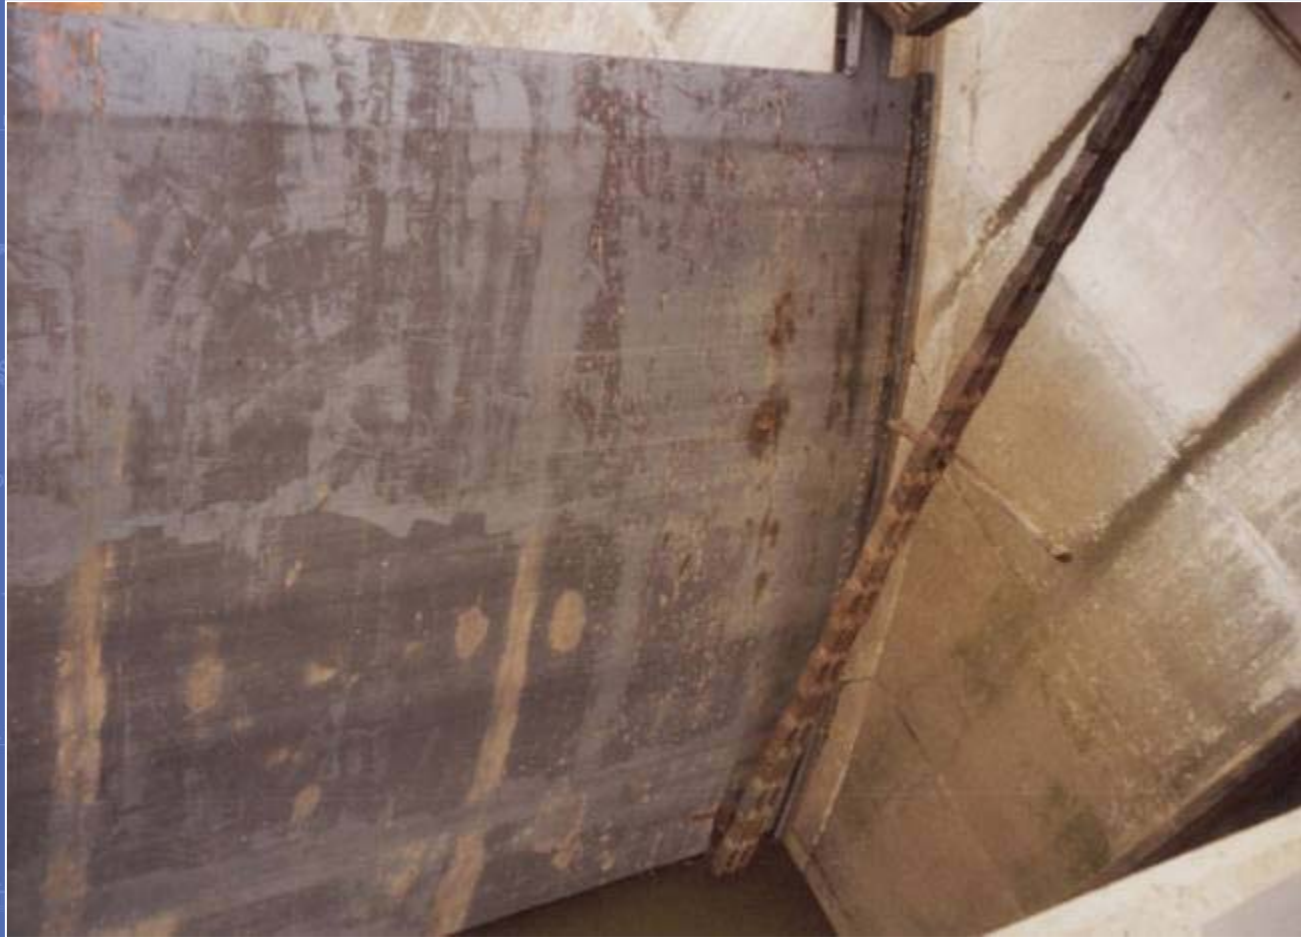
Inspect Chains And Cables Particularly At Waterline

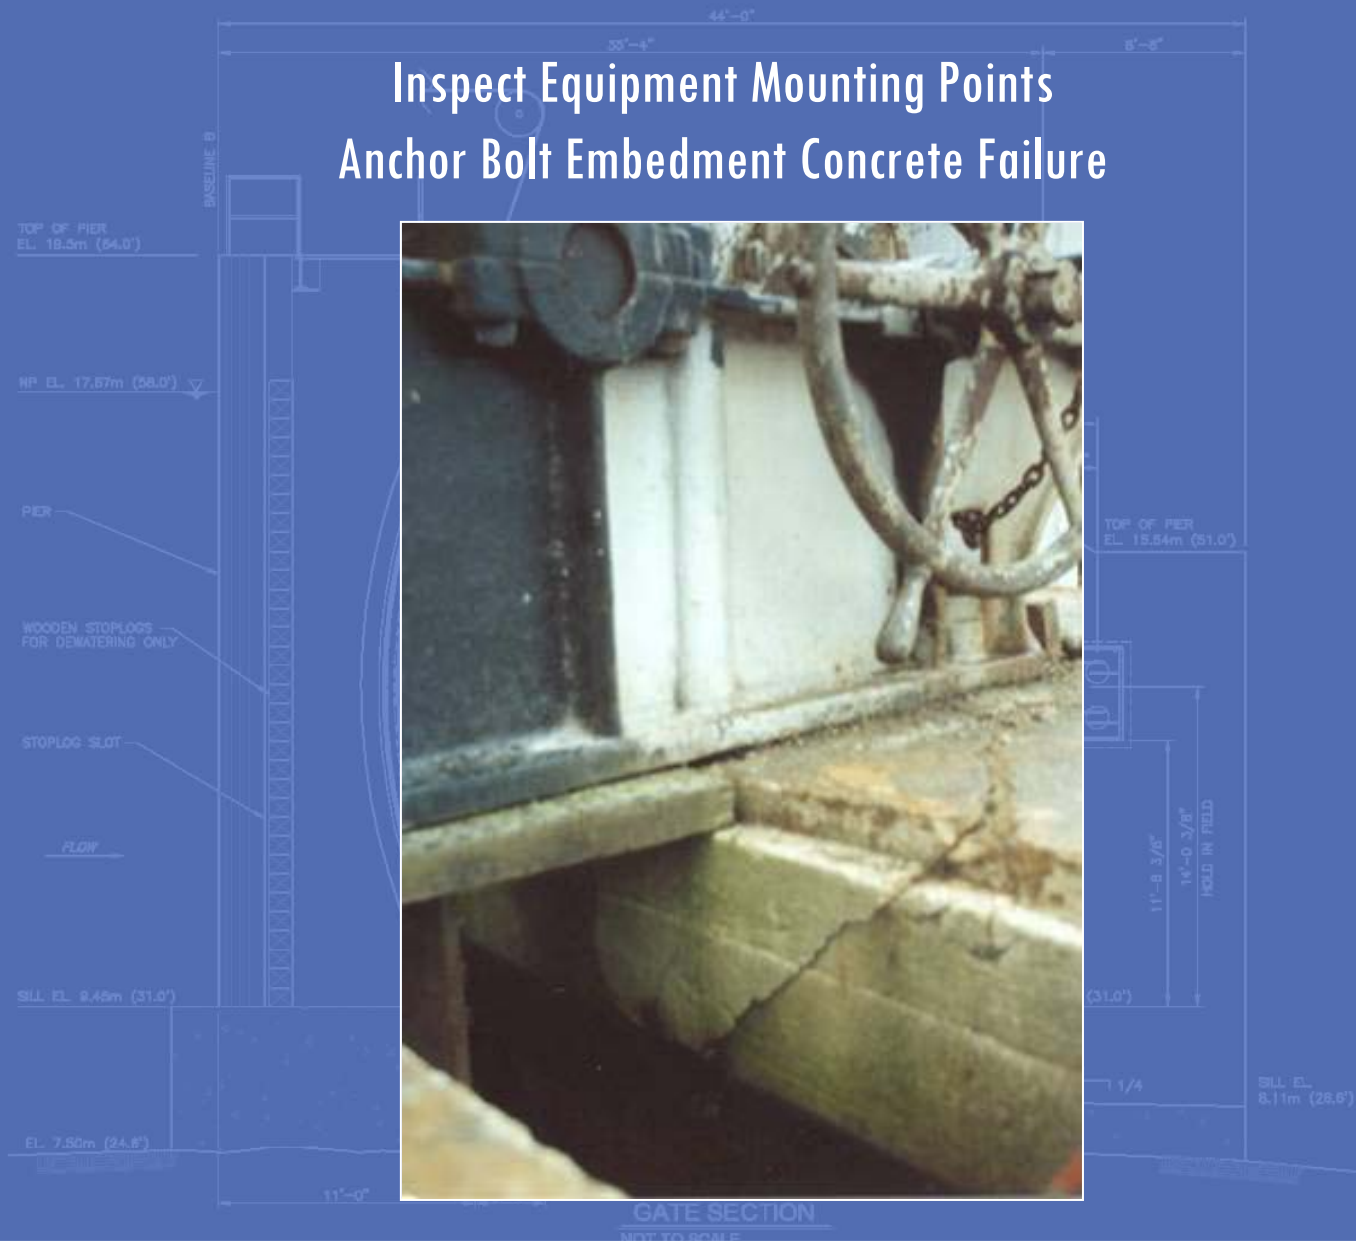
Inspect Equipment Mounting Points Anchor Bolt Embedment Concrete Failure

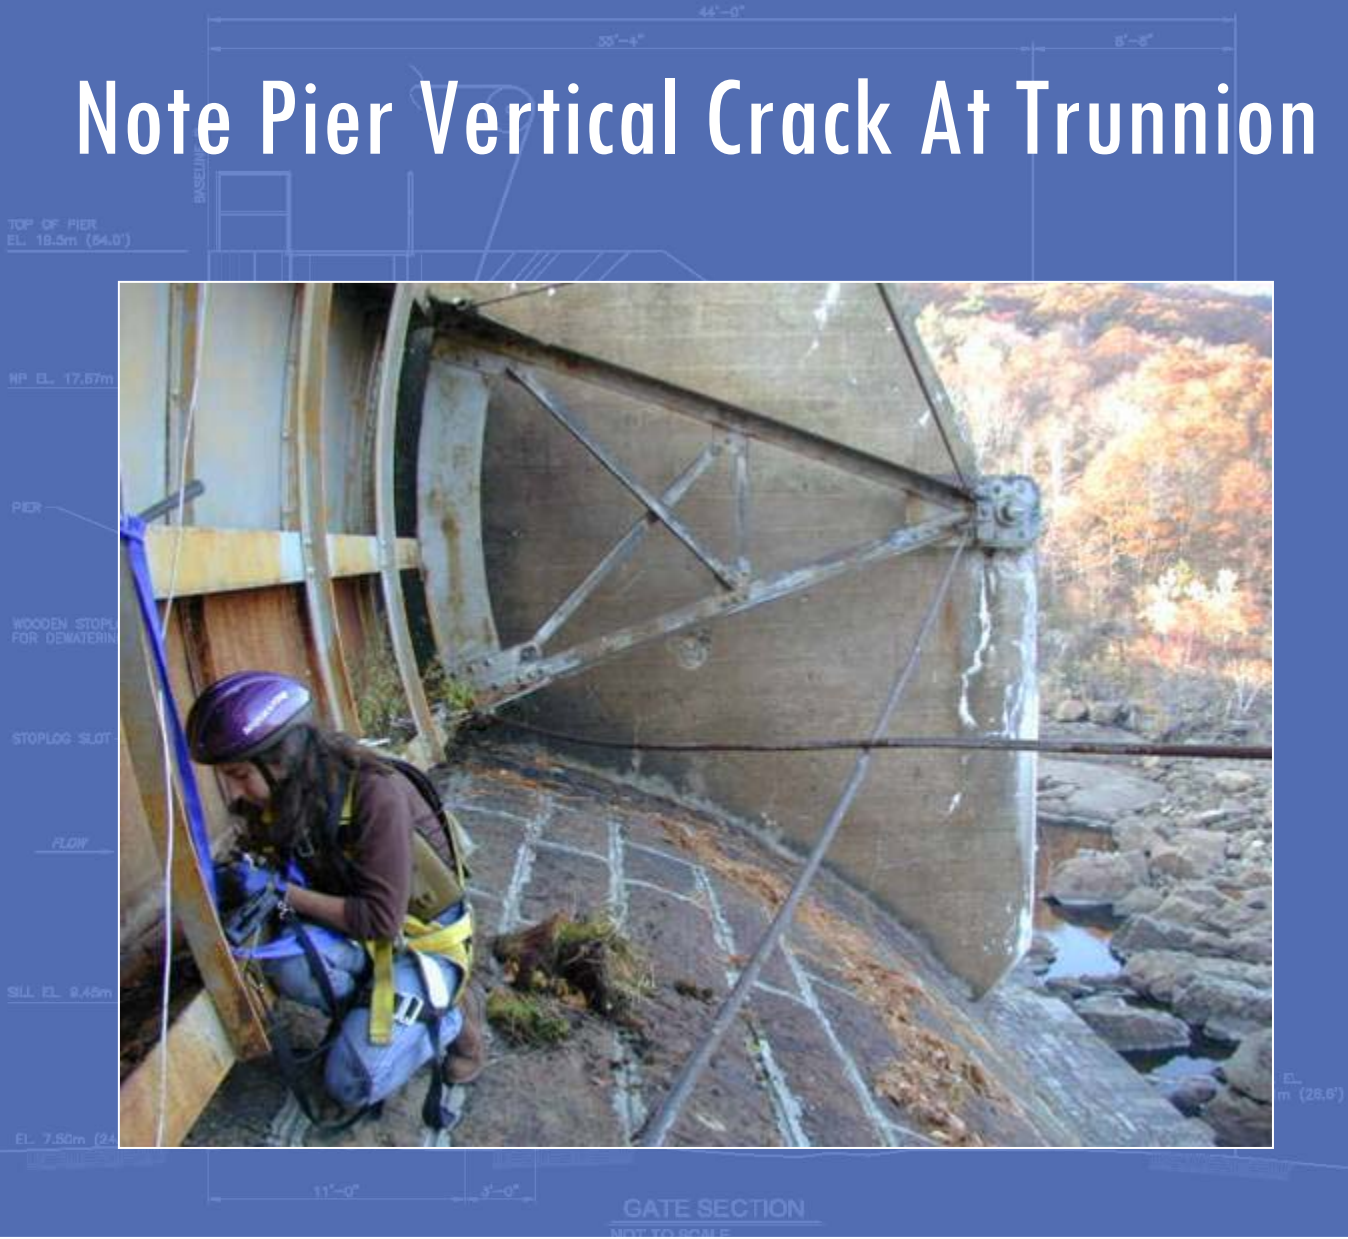
Note Pier Vertical Crack At Trunnion

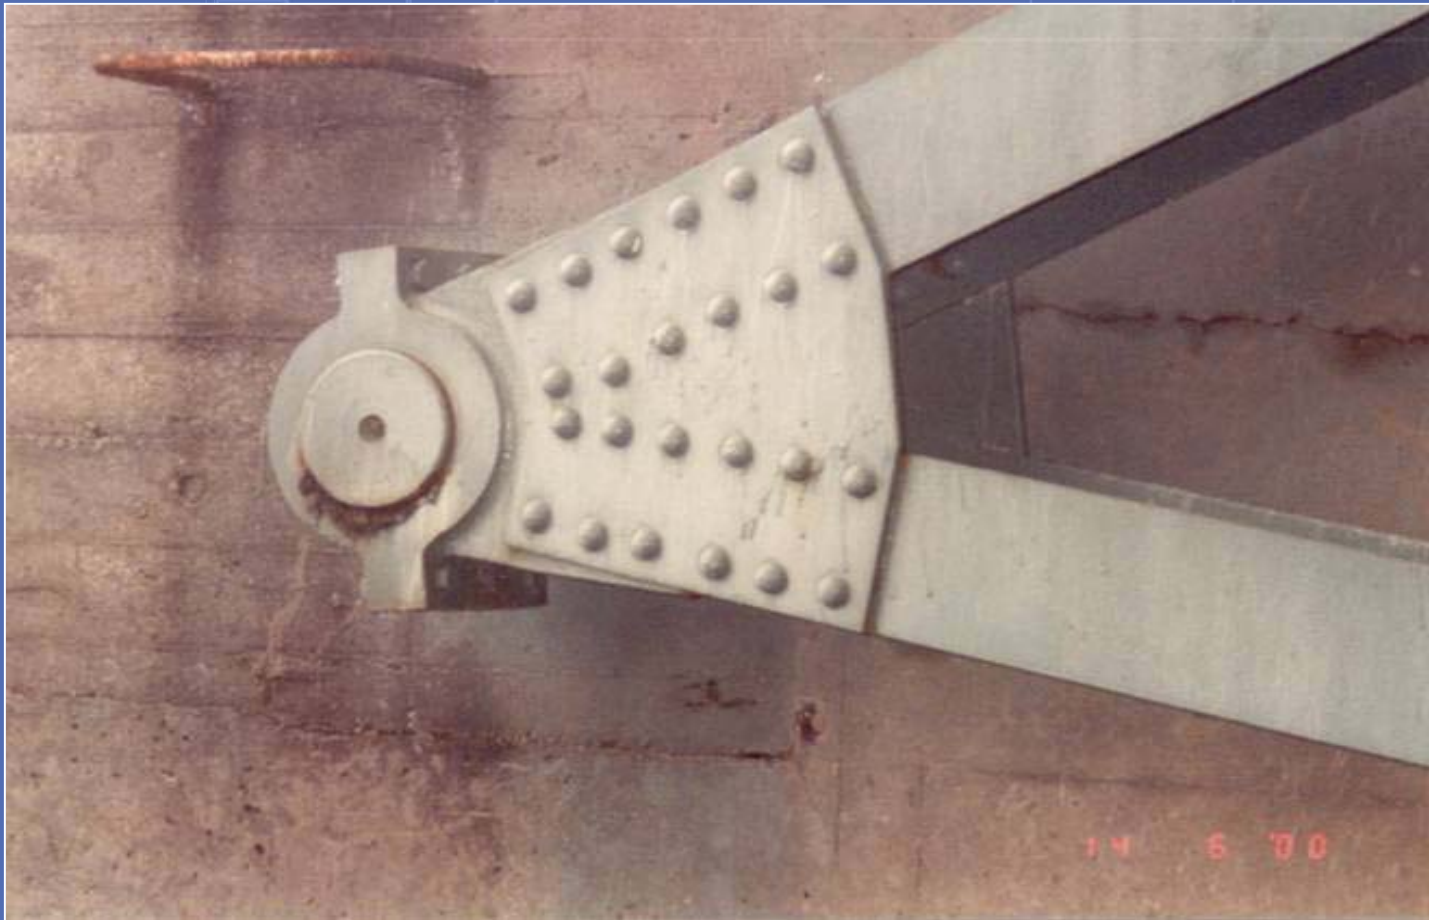
Extruded grease from 4 to 8 o'clock

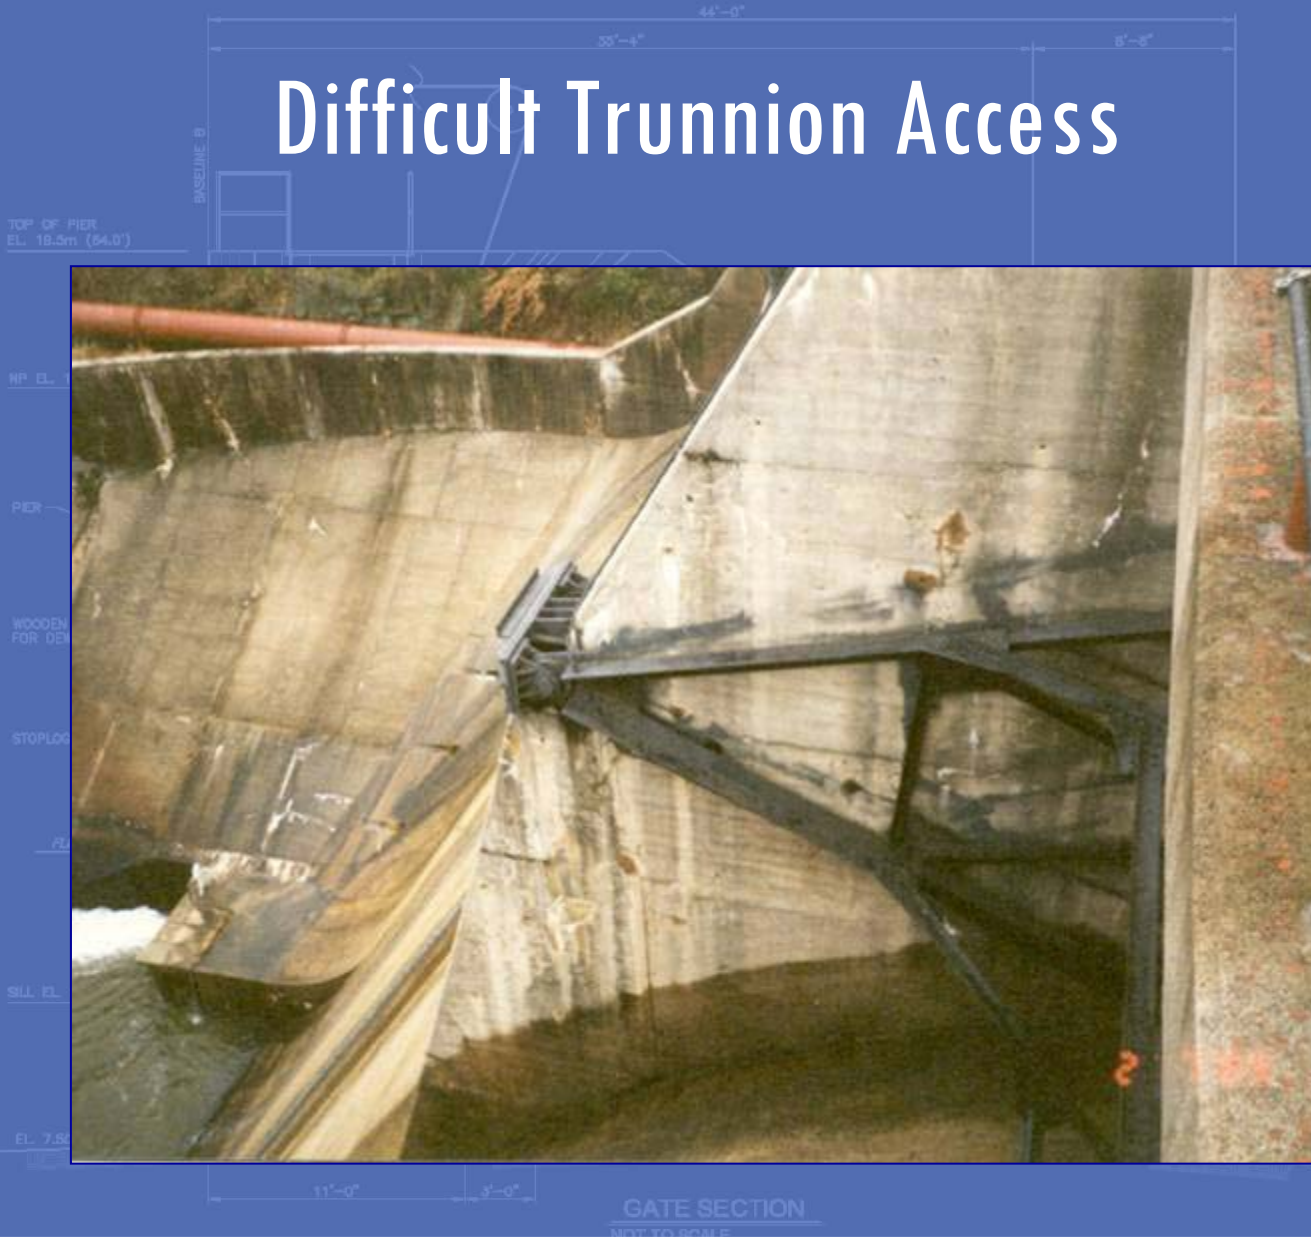
Difficult Trunnion Access
